**License & Insured**  
**HI 8149 CRC 1331177**  
**MRSA3289 MRSR 3370**

**6051 NW 61st ST Parkland, FL 33067**  
**ProInspectorsFl.com**  
**954.283.8989**

**Inspected by: Joe Vandino**

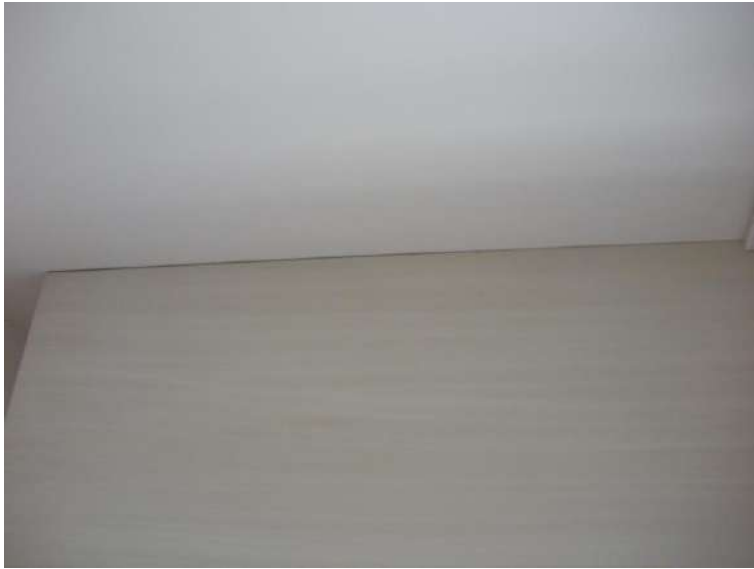
Exposed gap between the kitchen cabinet and the wall. Caulking and painting is recommended.

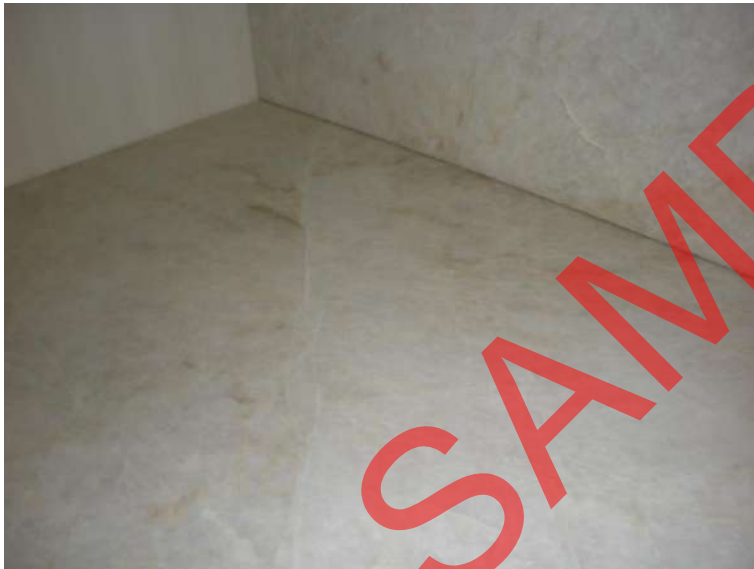
Multiple areas of the counter-tops are not water tight. Siliconing is recommended.

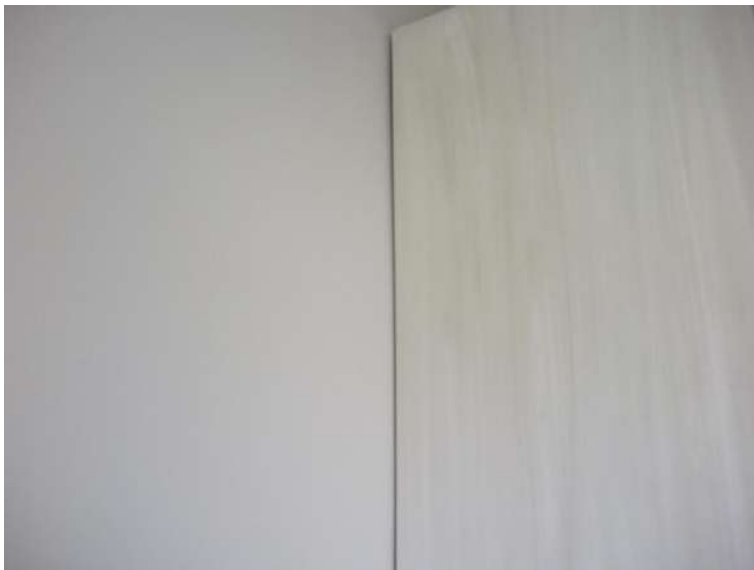
Exposed gap between the kitchen cabinet and the wall. Caulking and painting is recommended.

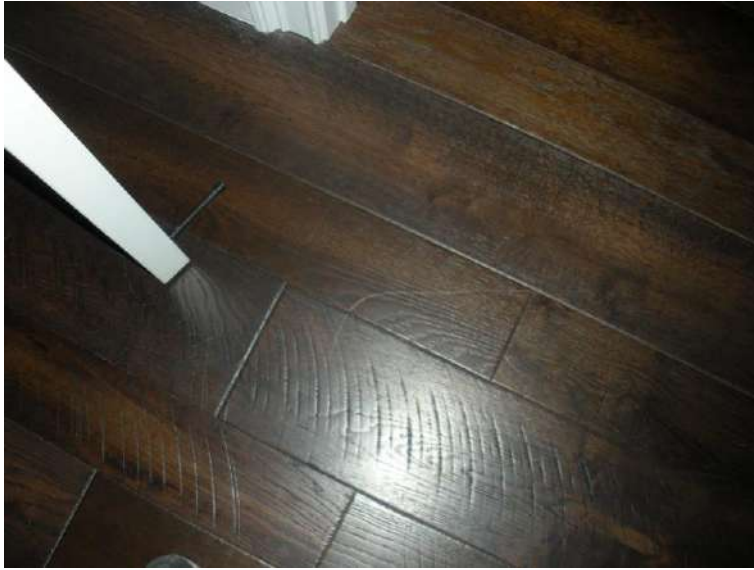
Door is bumping with the floor. Door needs adjustment, and flooring touch up is recommended.

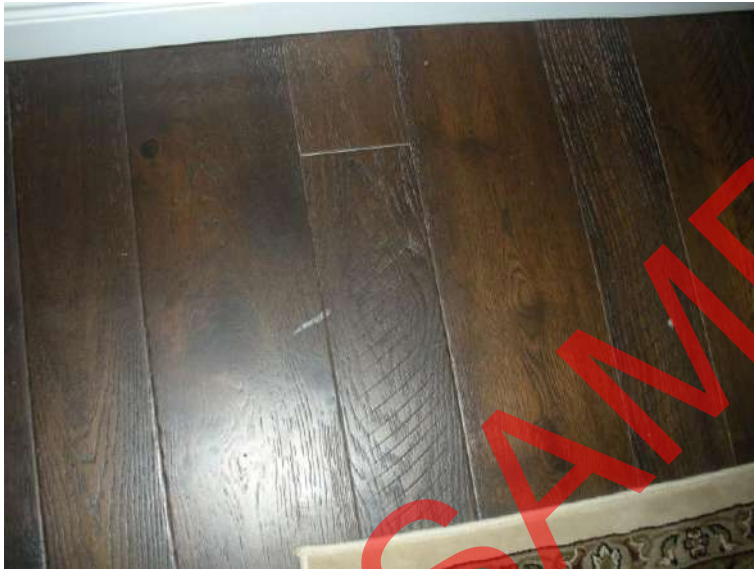
Multiple areas of the wood flooring show, paint marks, scratches and or dings into the planks.

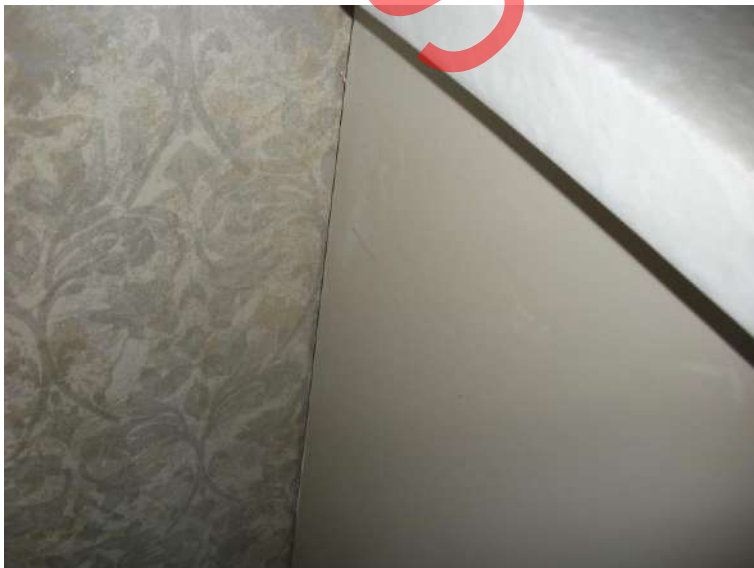
Exposed gap between the kitchen cabinet and the wall. Caulking and painting is recommended. Possible not done since no matching caulk or paint is available, and disguising is achieved by wallpapering to the edge.

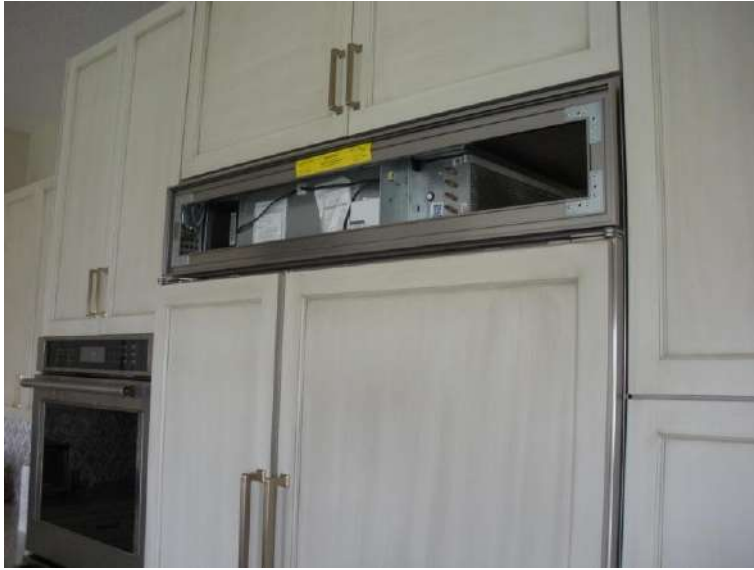
Kitchen shows missing matching panel on the refrigerator.

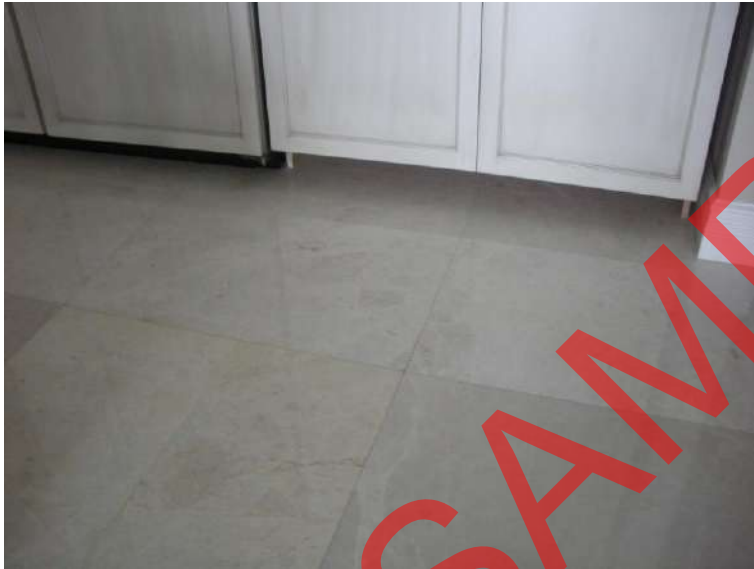
Some toe kicks are missing in the kitchen cabinetry.

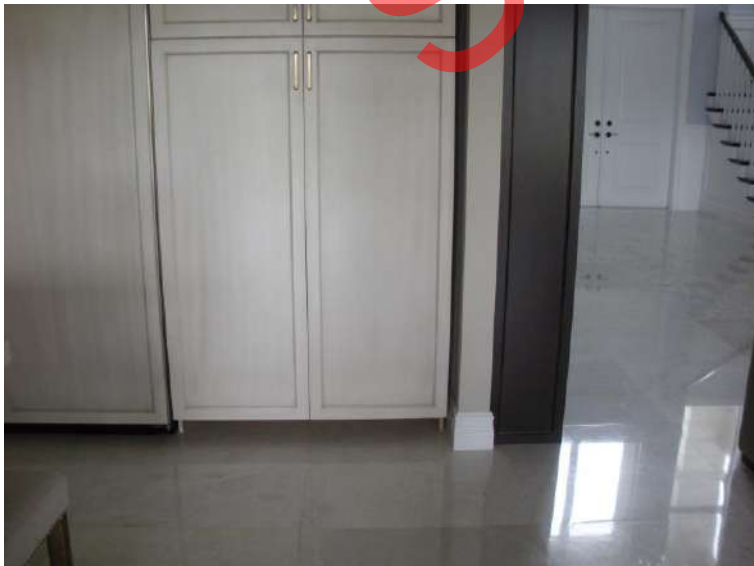
Toe kicks and filler strip are missing in the kitchen cabinetry.

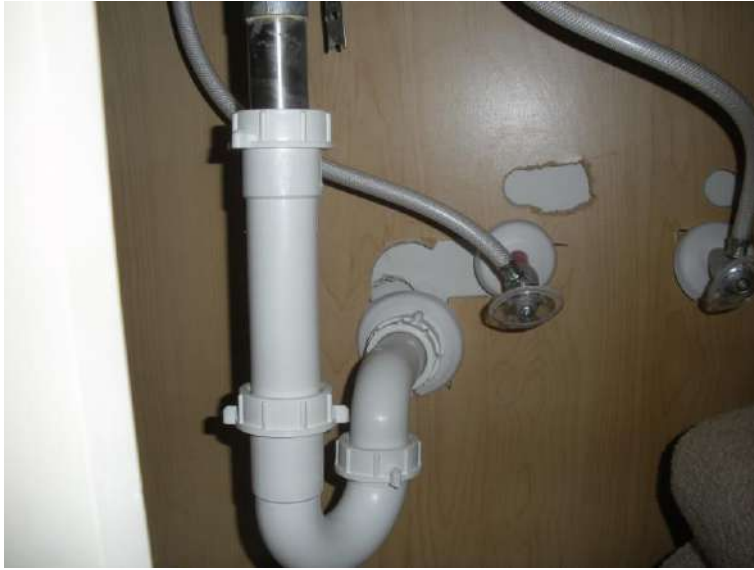
Many cabinetry show open voids around the pipes. Sealing to close the voids is recommended to achieve to standard fire rating.

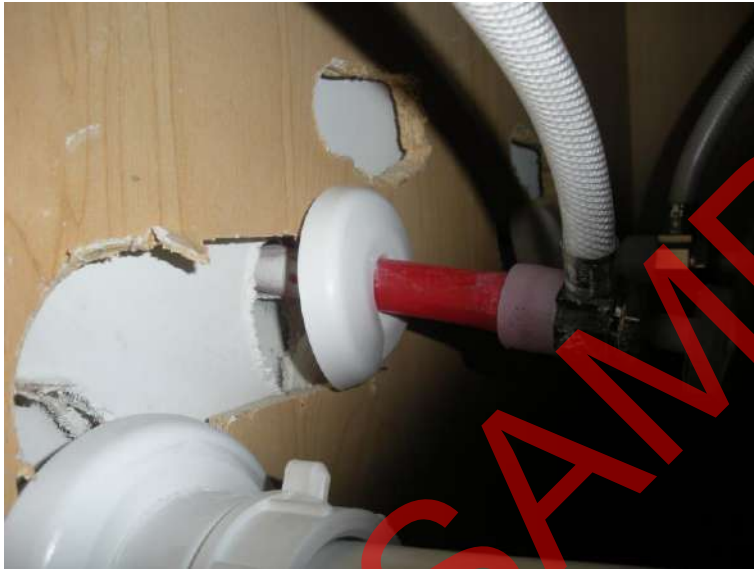
Many cabinetry show open voids around the pipes. Sealing to close the voids is recommended to achieve to standard fire rating.

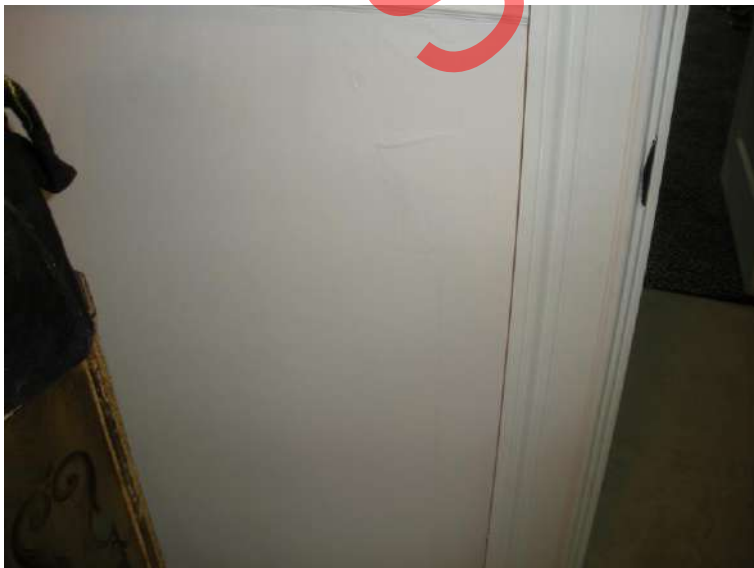
Multiple walls and ceilings show unfinished drywall. Texture, and paint is recommended.

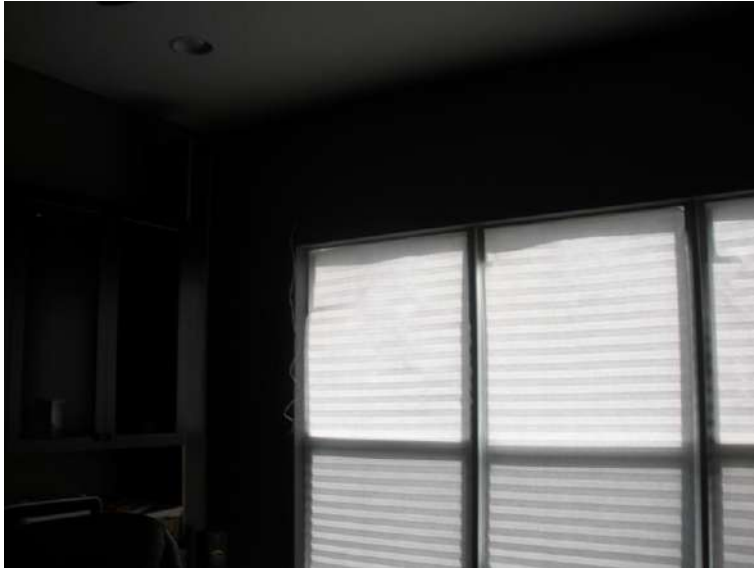
All windows show exposed wiring, to power motorized shades. No mechanism was present during the inspection.

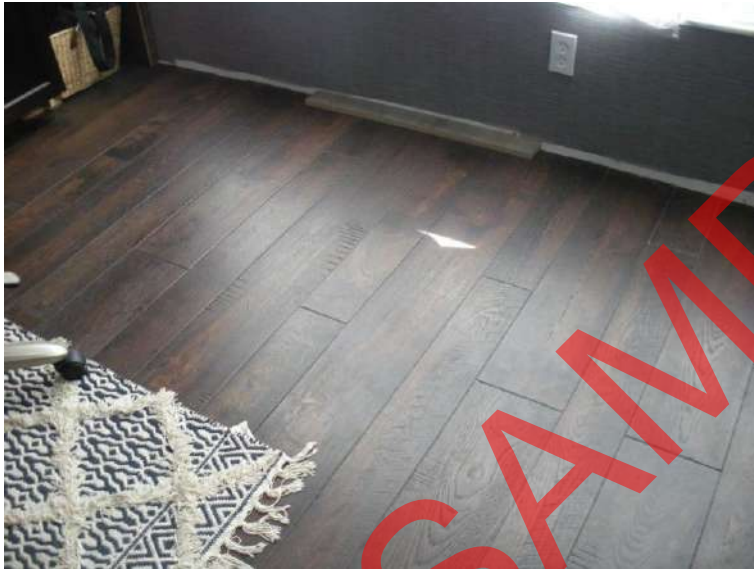
Missing baseboards in the office

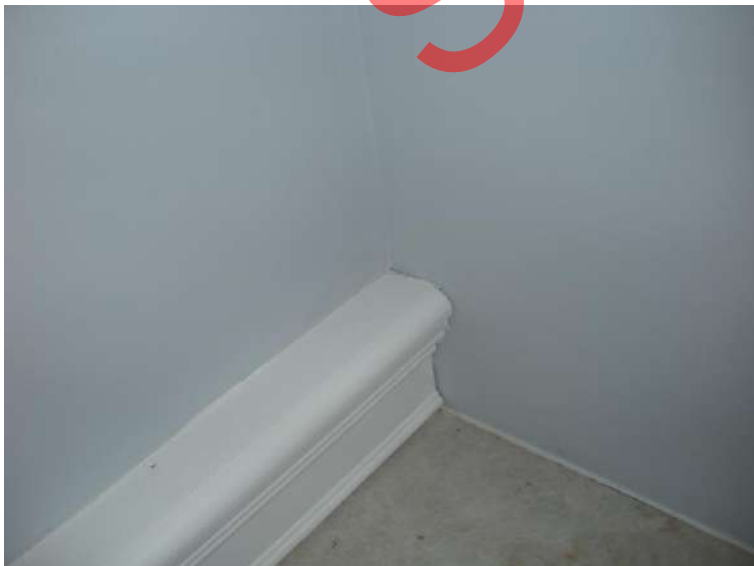
Missing caulk and touch up on molding.

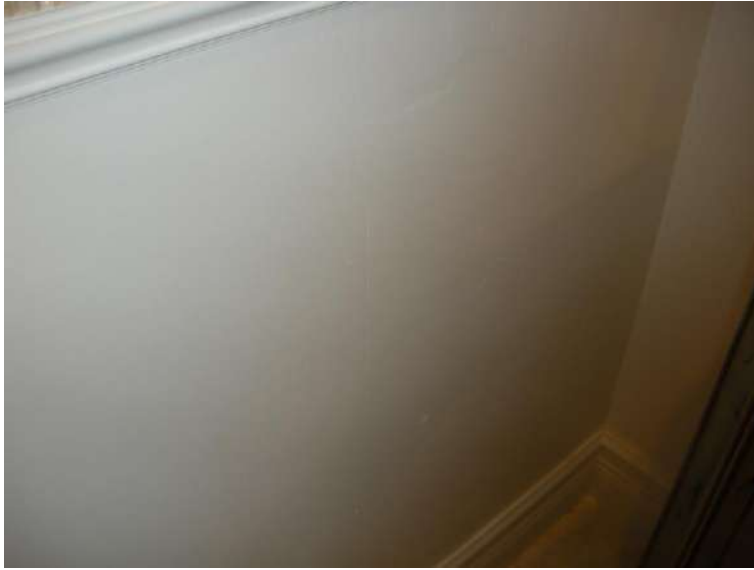
Multiple walls and ceilings show unfinished drywall. Texture, and paint is recommended.

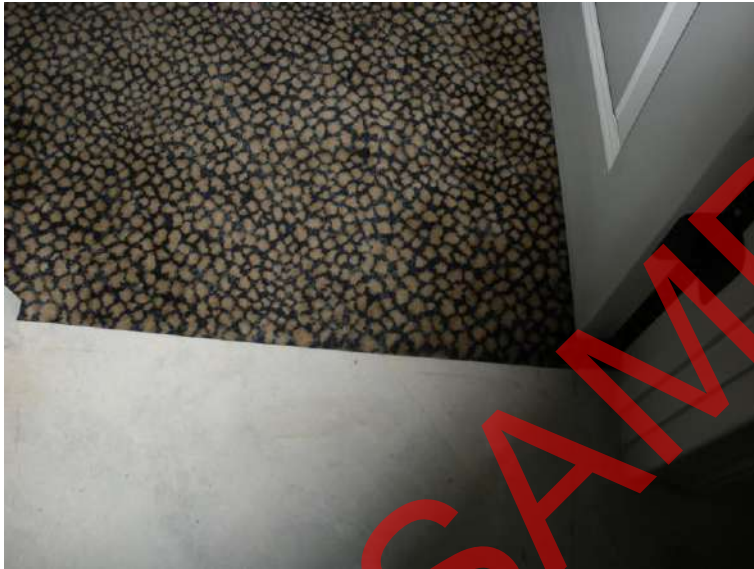
A few doorways are missing transition thresholds.

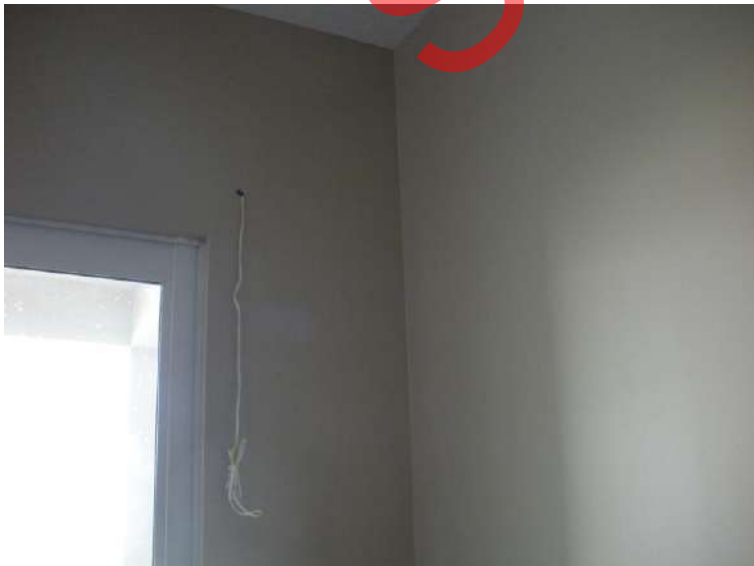
All windows show exposed wiring, to power motorized shades. No mechanism was present during the inspection.

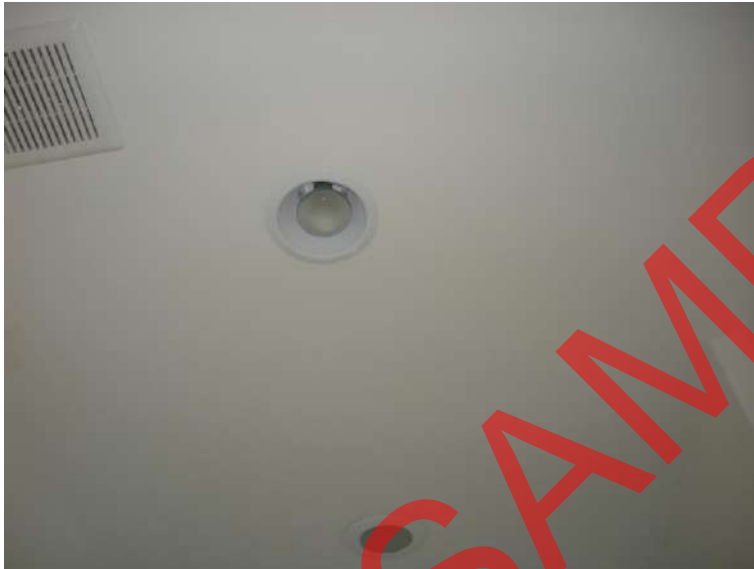
Multiple walls and ceilings show unfinished drywall. Texture, and paint is recommended.

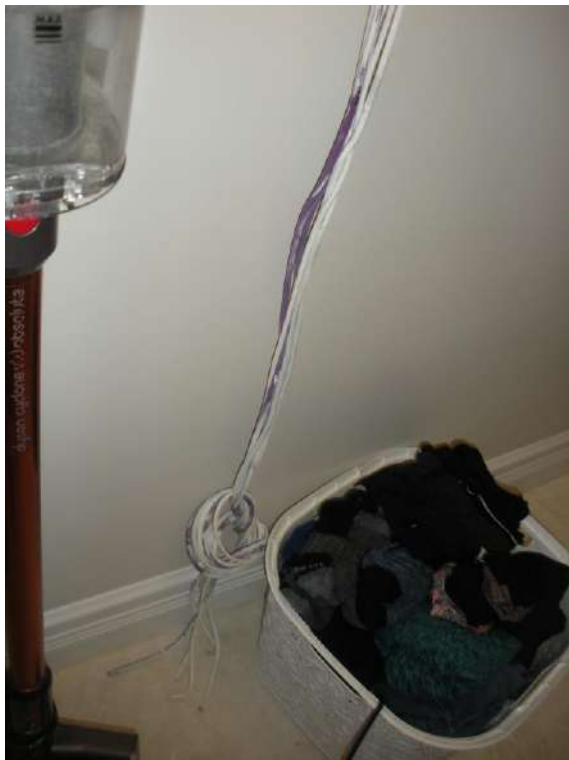
All windows show exposed wiring, to power motorized shades. No mechanism was present during the inspection.

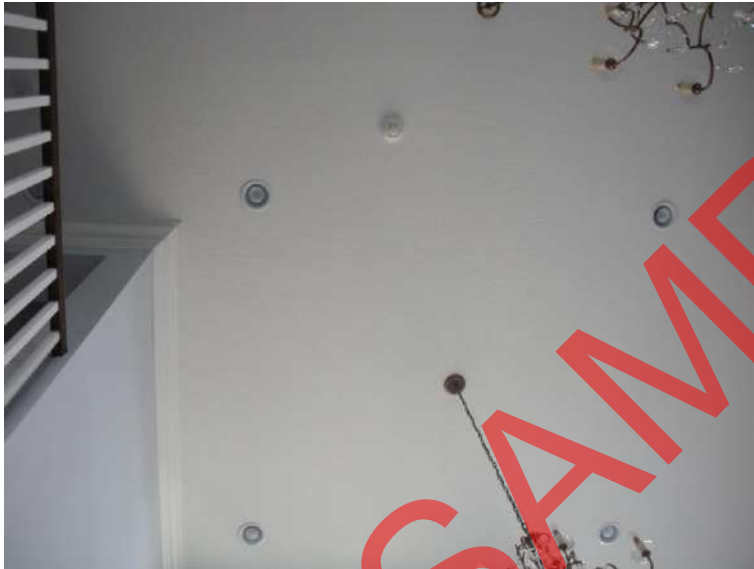
Multiple walls and ceilings show unfinished drywall. Texture, and paint is recommended.

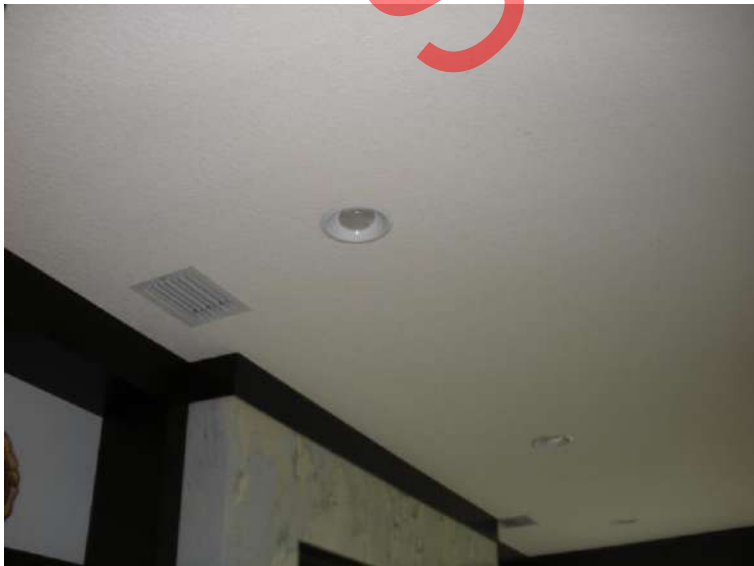
Multiple walls and ceilings show unfinished drywall. Texture, and paint is recommended.

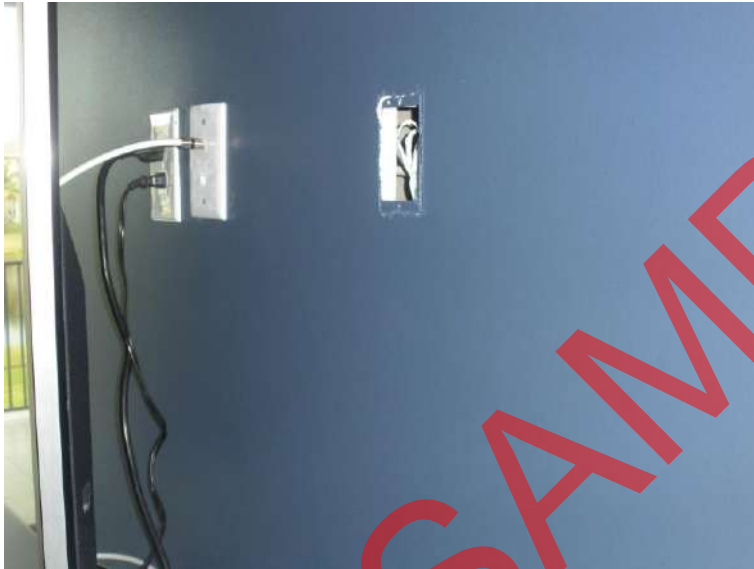
Exposed wiring, covering with blank plate is recommended.

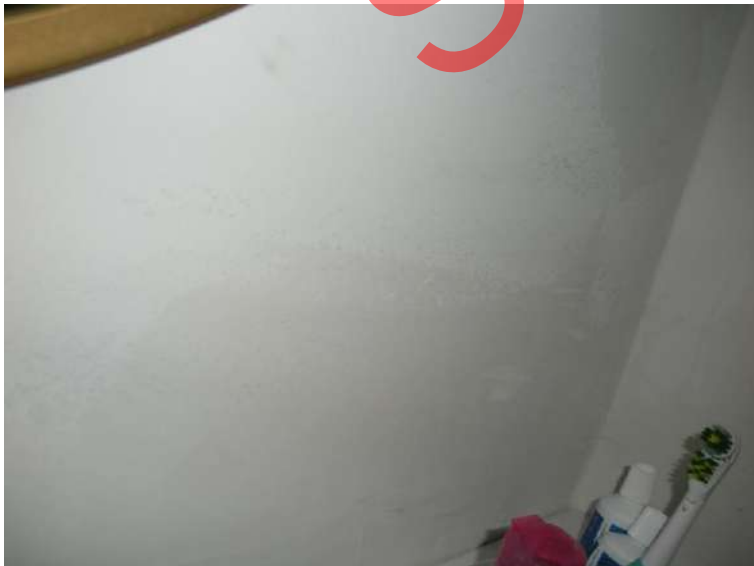
Multiple walls and ceilings show unfinished drywall. Texture, and paint is recommended.

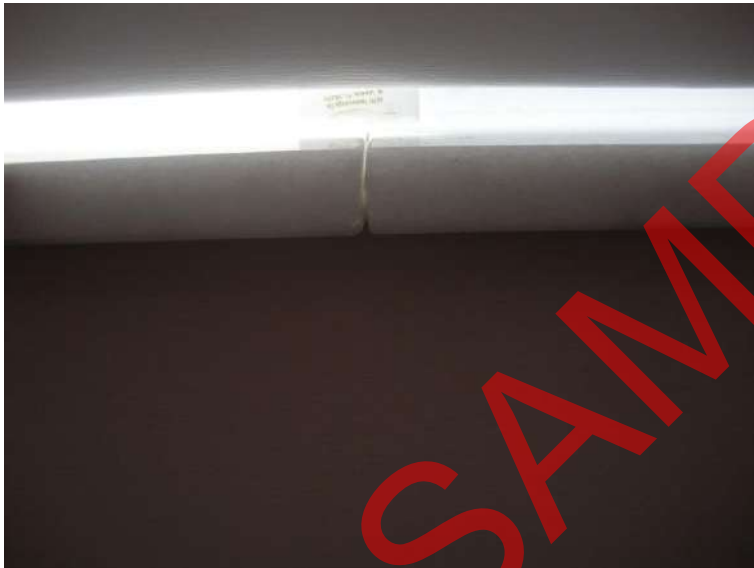
Cracked window sill

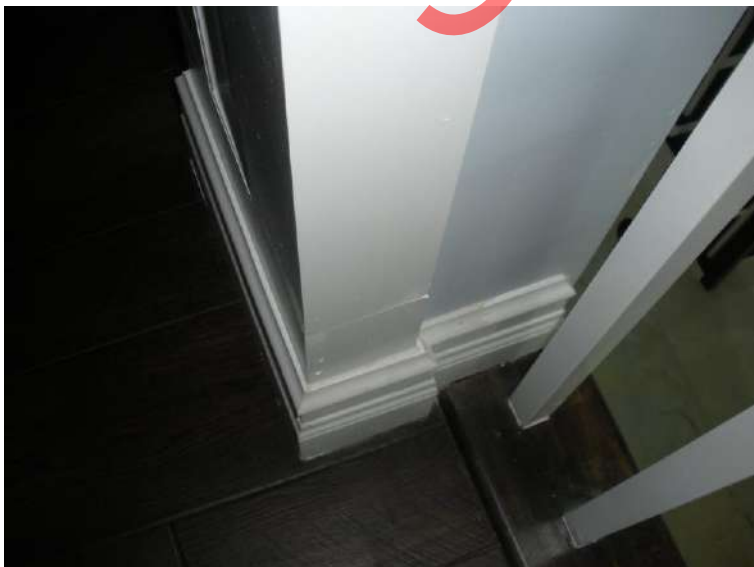
Multiple walls and ceilings show unfinished drywall. Texture, and paint is recommended.

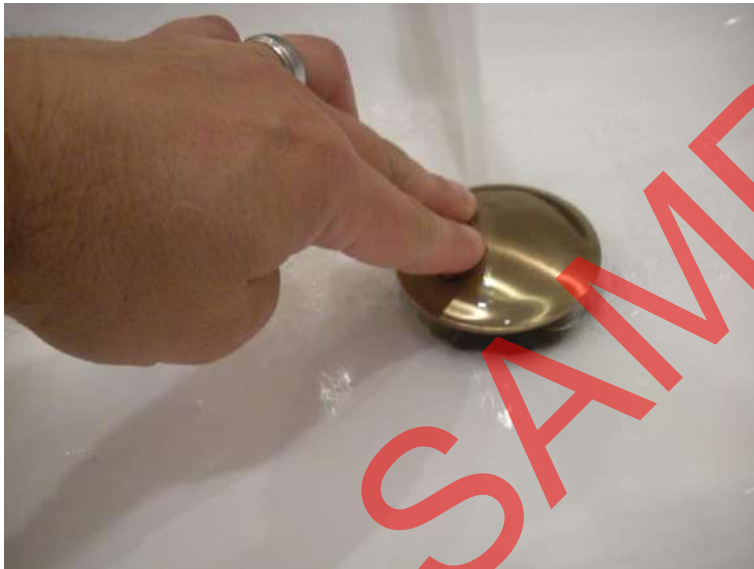
Pop Drain not operable.

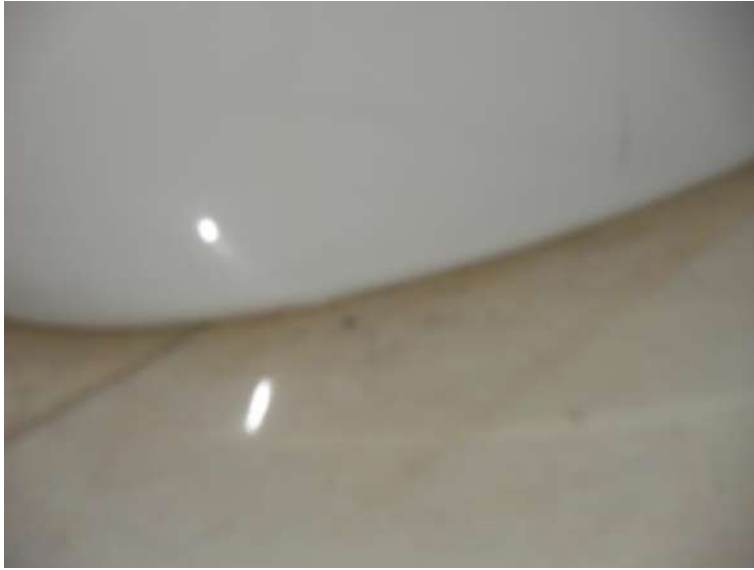
Toilet missing grout at the base.

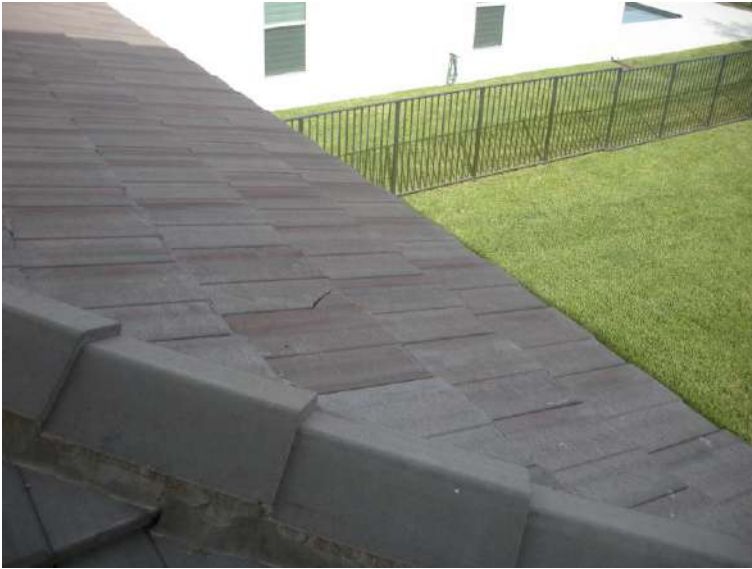
Some cracked roof tiles are evident on some roof pitches.

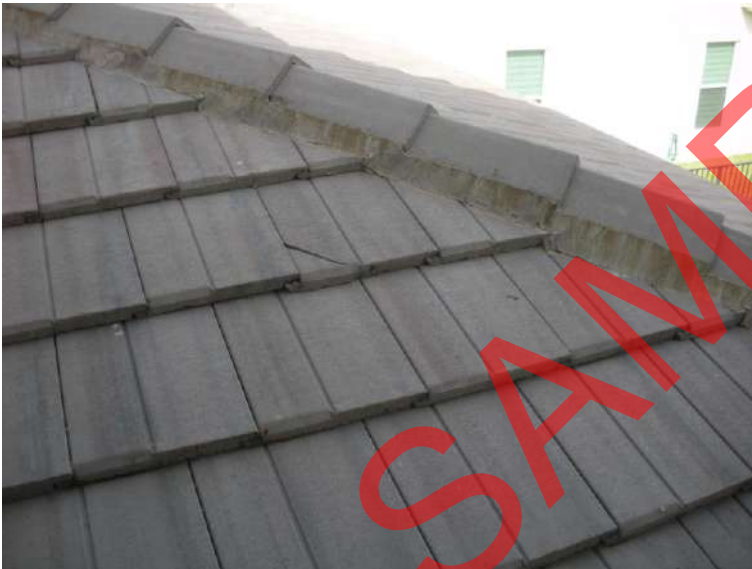
Some cracked roof tiles are evident on some roof pitches.

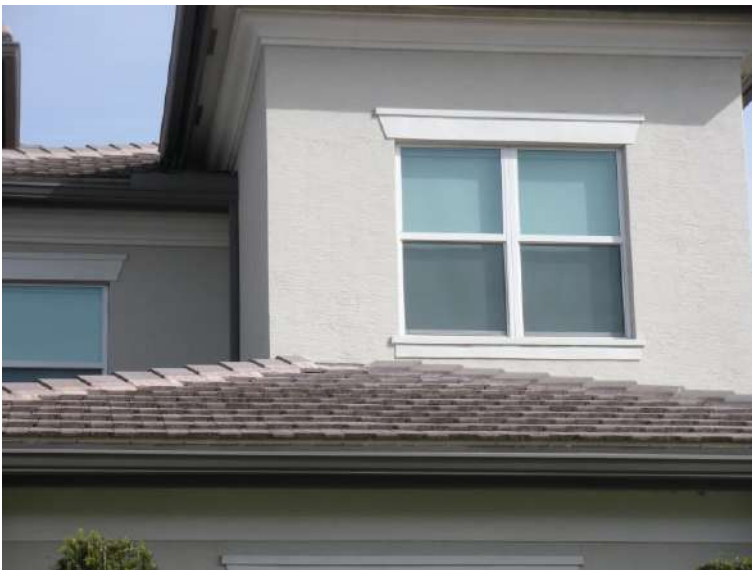
Some cracked roof tiles are evident on some roof pitches.

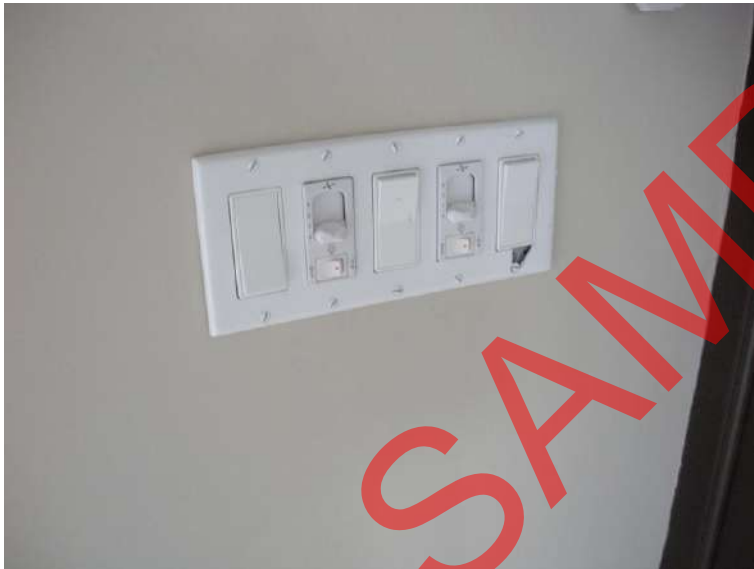
Broken recepticle plate.

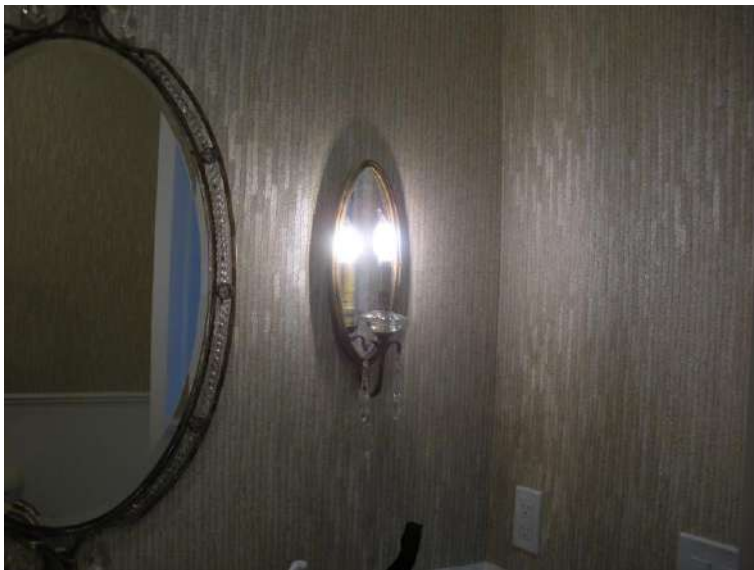
Light fixture is missing globe.

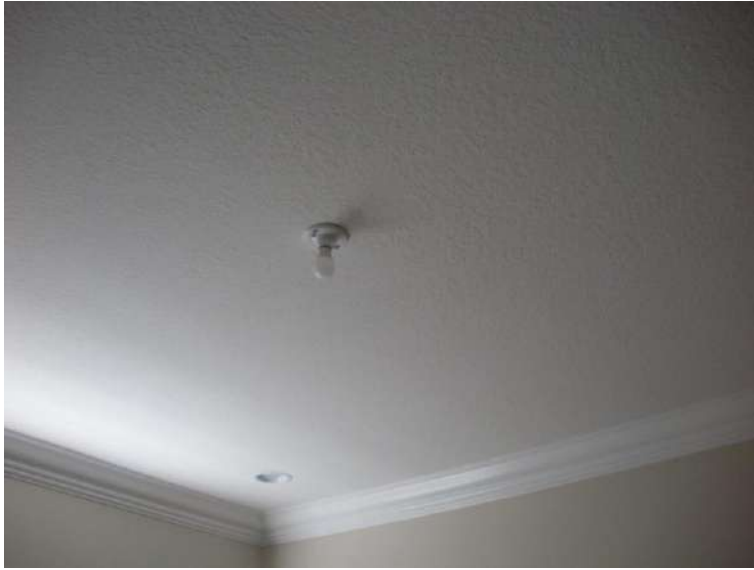
Multiple rooms light fixtures are missing globes.

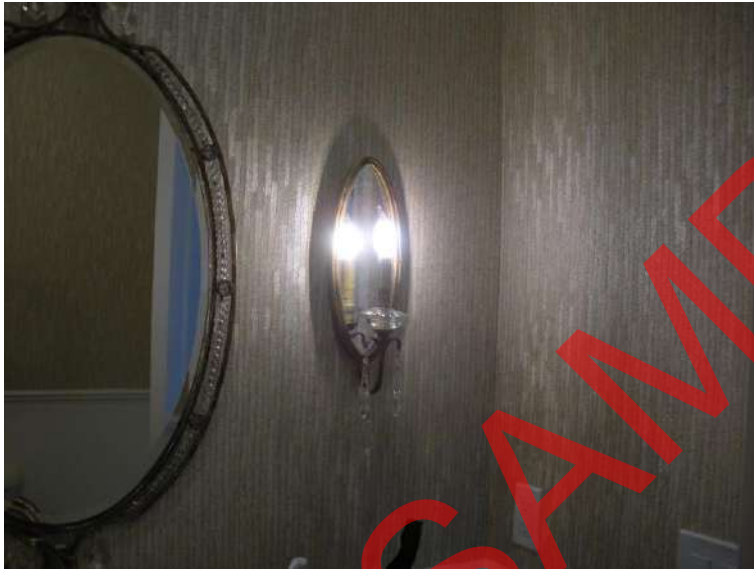
Multiple rooms light fixtures are missing globes.

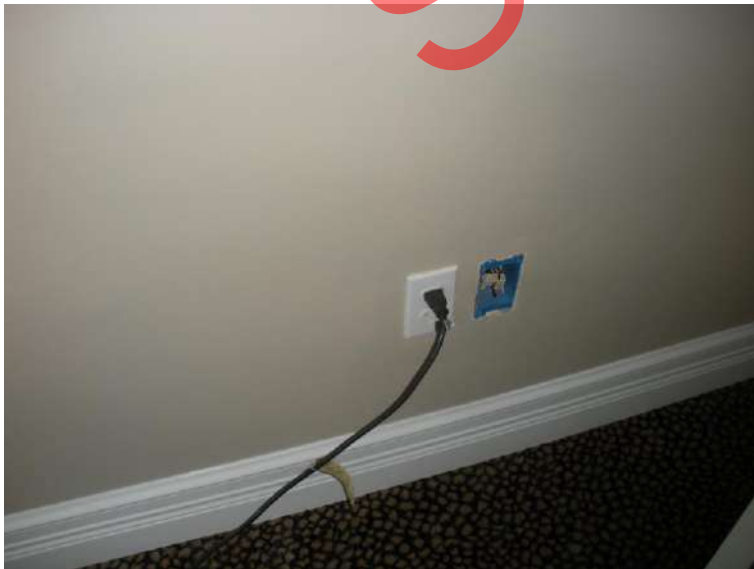
Exposed wiring in box. Cover plate installation is recommended.

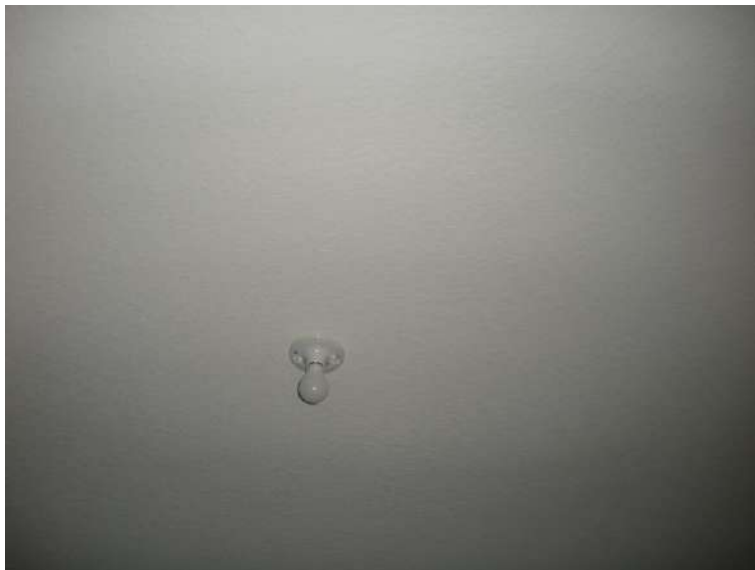
Multiple rooms light fixtures are missing globes.

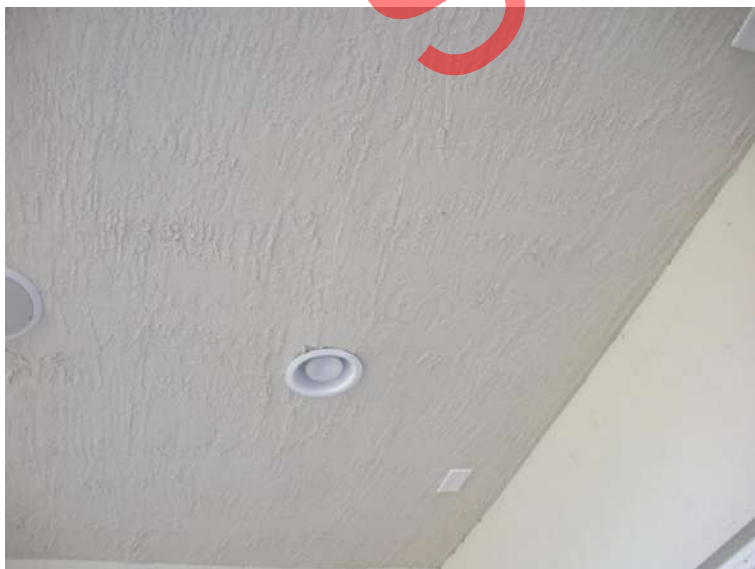
Exterior light fixtures are recommended to be fully water and moisture resistant.

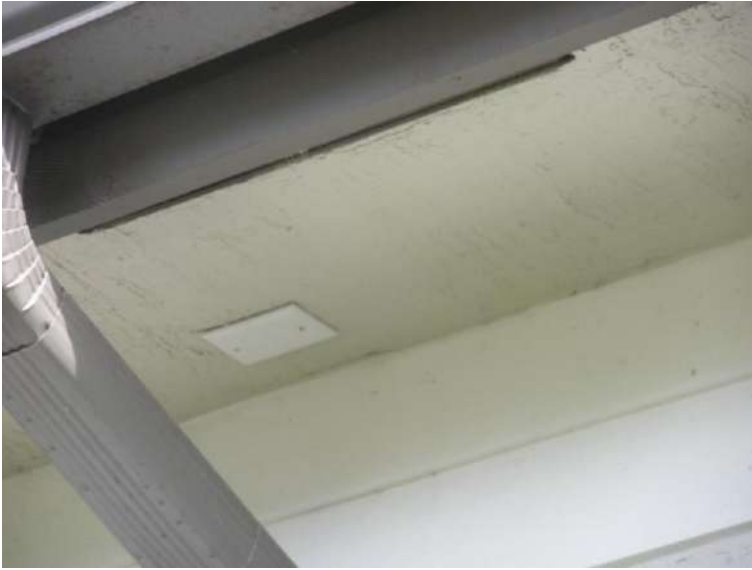
Exterior light fixtures and covers are recommended to be fully water and moisture resistant.

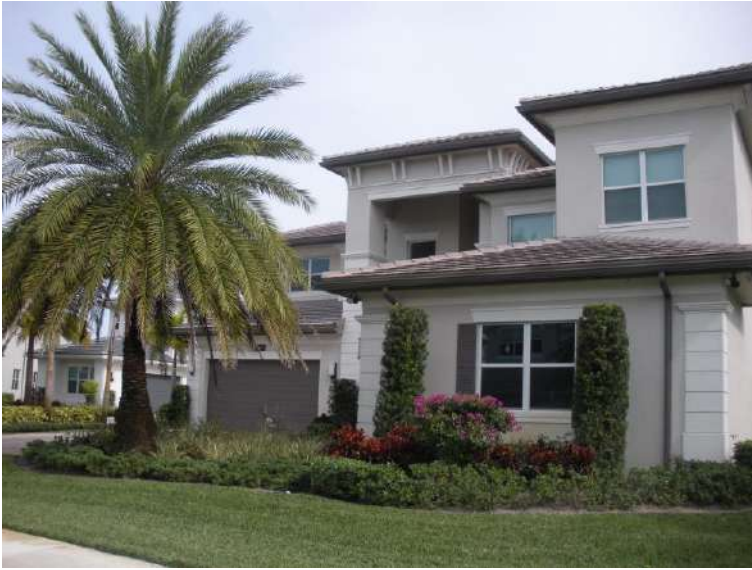
Front elevation shows landscape to close to structure. Landscape is recommended to be at a minimum of 2 feet away from the property to prevent moisture and pest intrusion.

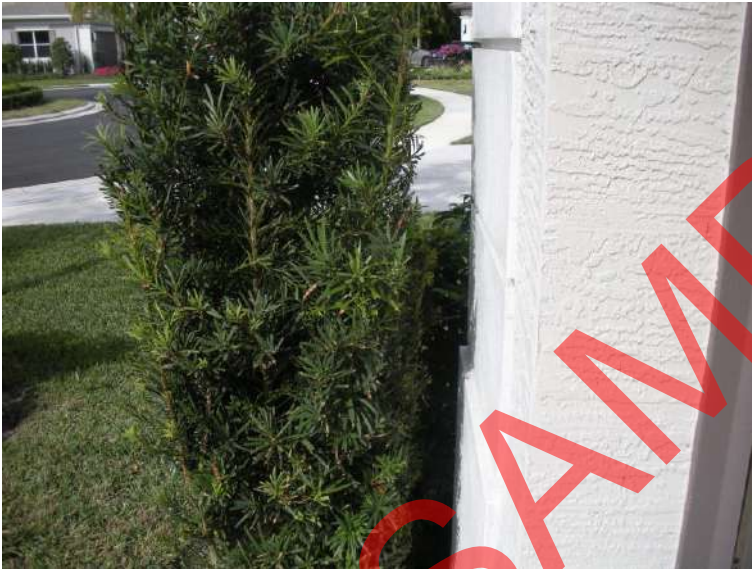
Landscape to close to property is not advised. Standard recommended distance is 2-4 feet away from the structure, to prevent water and insect intrusion.

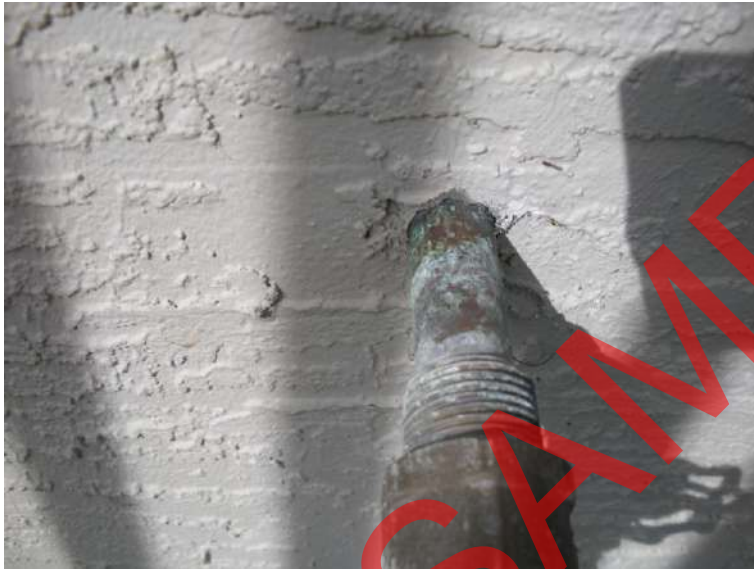
Pipe is not watertight, siliconing is recommended to prevent water intrusion.

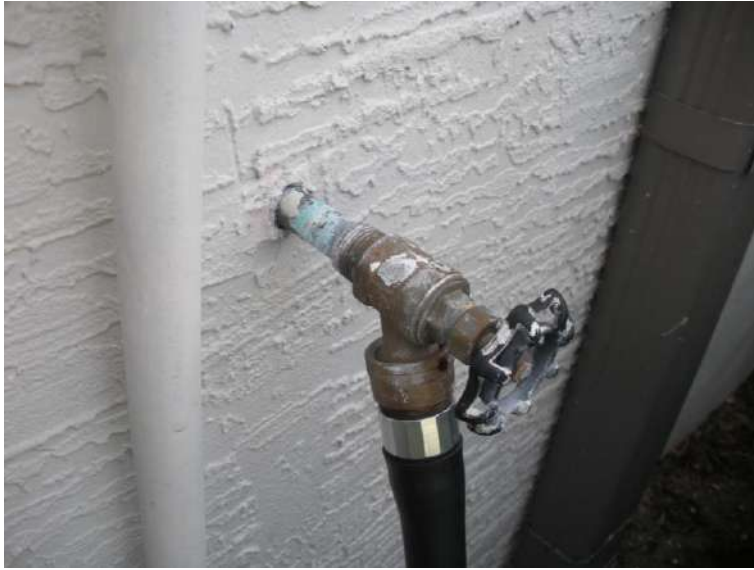
Pipe is not watertight, siliconing is recommended to prevent water intrusion.

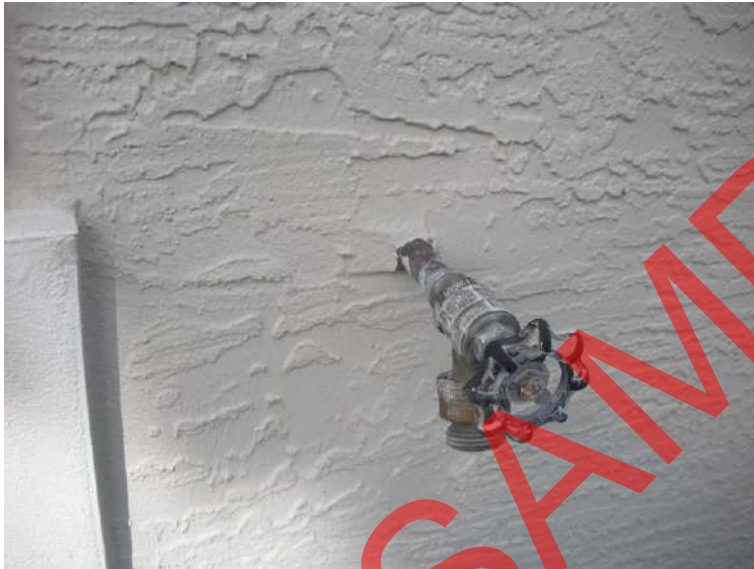
Pipe is not watertight, siliconing is recommended to prevent water intrusion.

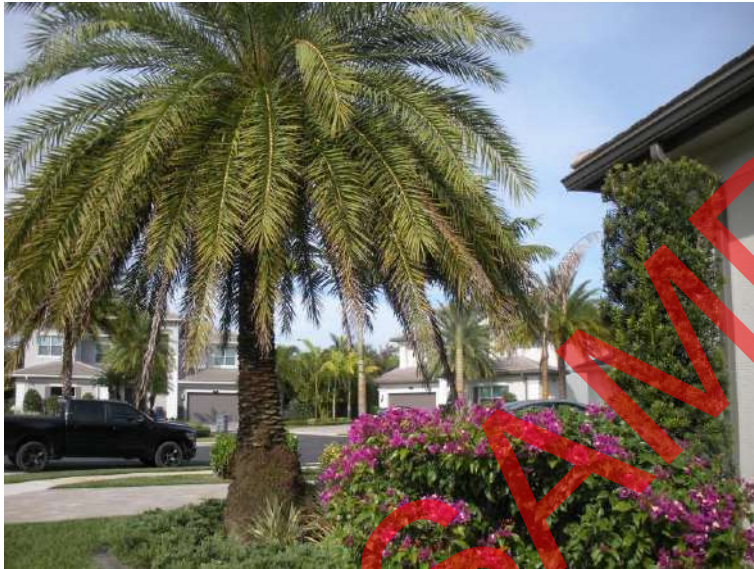
Landscape too close to property is not advised. Standard recommended distance is 2-4 feet away from the structure, to prevent water and insect intrusion.

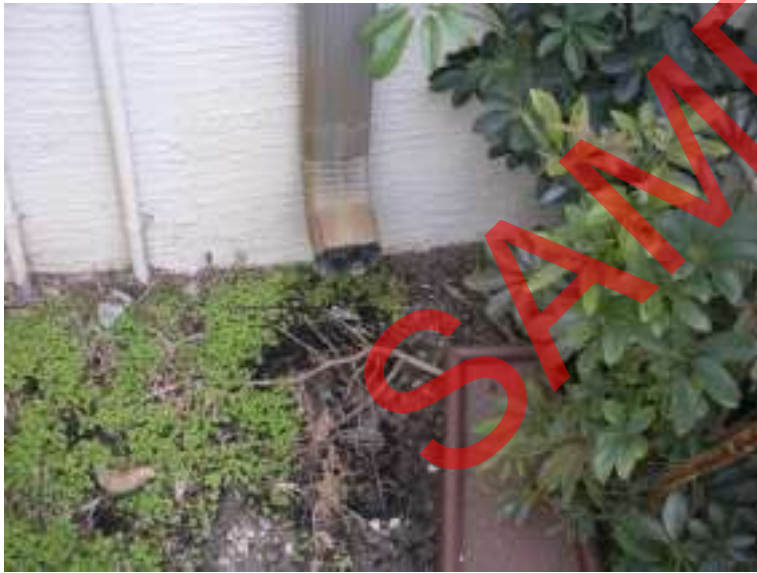
Down spout water diverter is not placed under the spout. Adjustment is recommended.

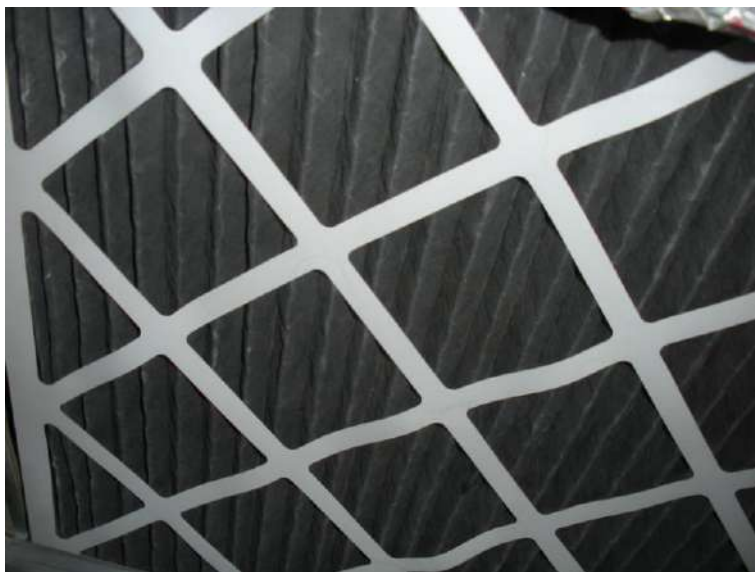
Filter change is recommended.

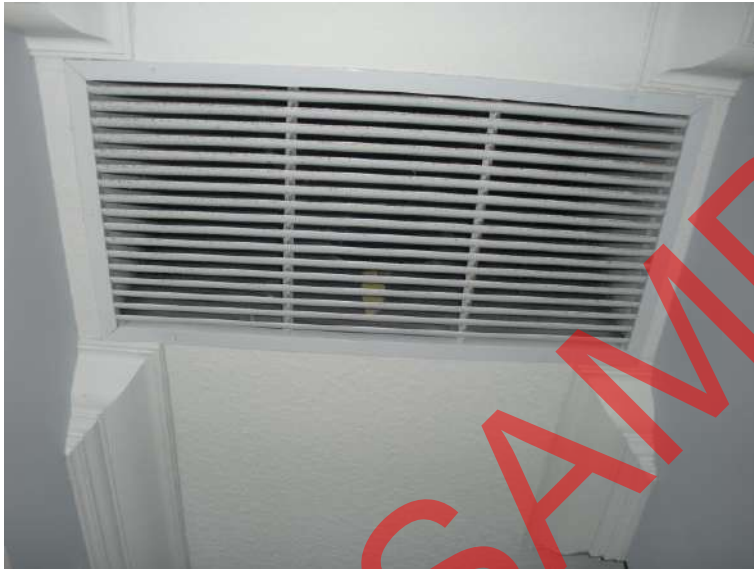
Filter change is recommended

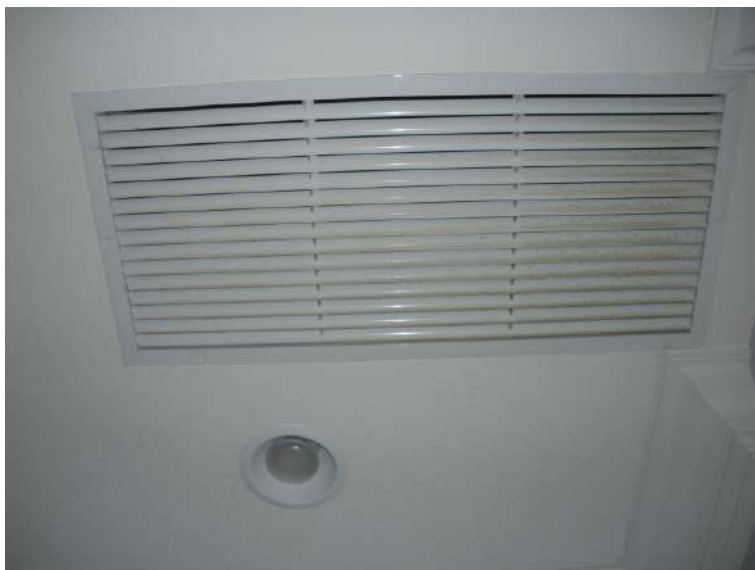
Return grills are dusty and it is recommended to clean to prevent all build up to be caught on the filter.

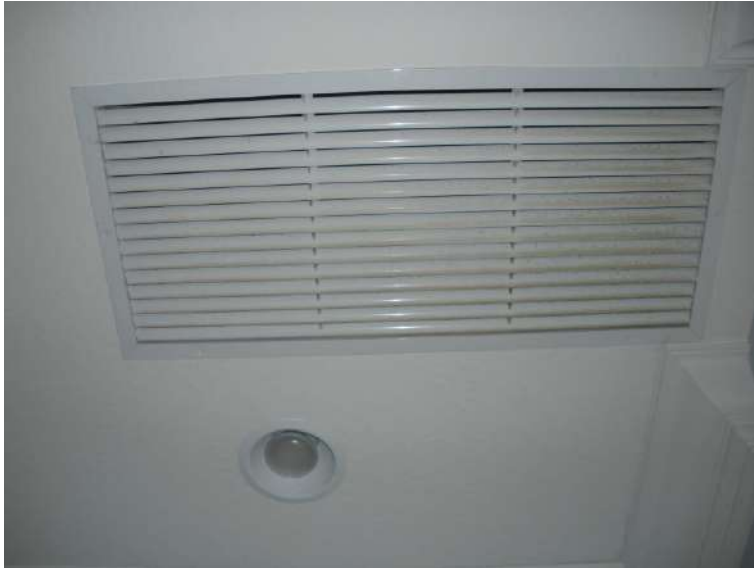
Return grills are dusty and it is recommended to clean to prevent all build up to be caught on the filter.
