**License & Insured**  
**HI 8149 CRC 1331177**  
**MRSA3289 MRSR 3370**

**6051 NW 61st ST Parkland, FL 33067**  
**ProInspectorsFl.com**  
**954.283.8989**

**Inspected by: Joe Vandino**

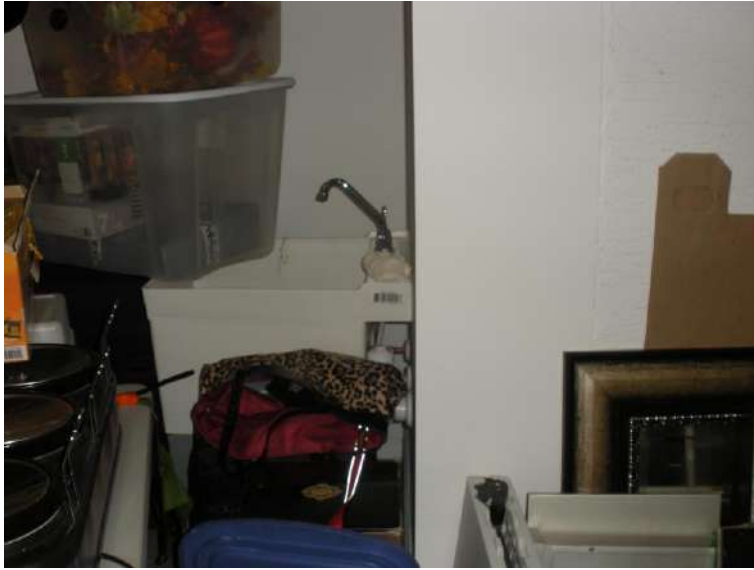
Gas Water Heater

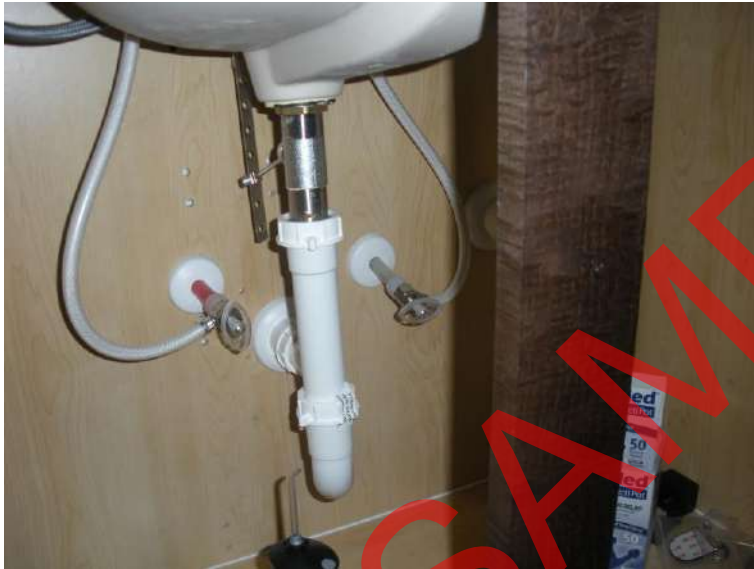
Obstructed sink. No access to inspect.

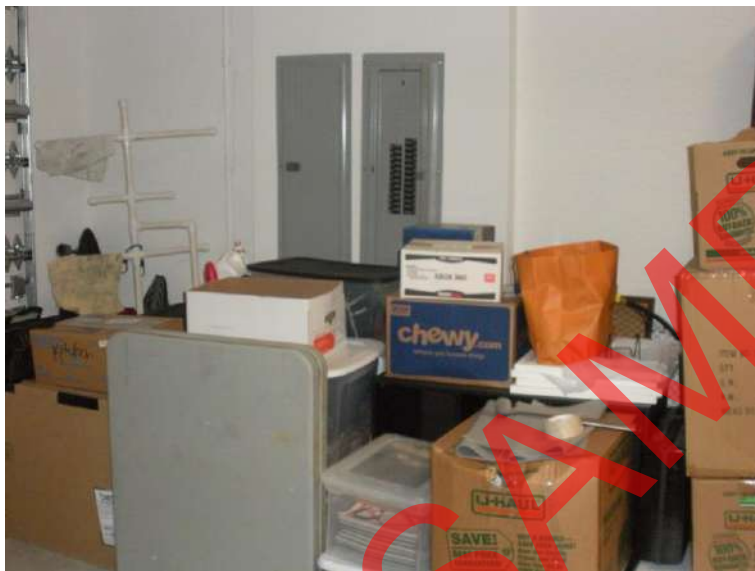
Panel label

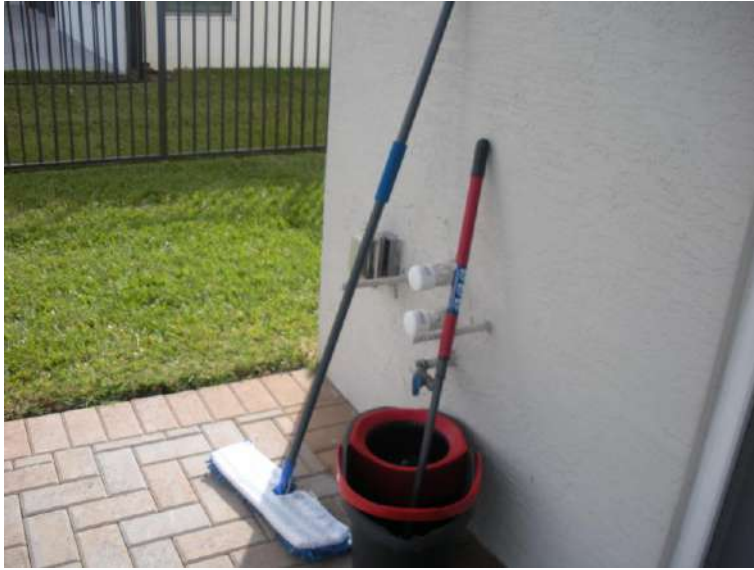
Landscape to close to property is not advised. Standard recommended distance is 2-4 feet away from the structure, to prevent water and insect intrusion.

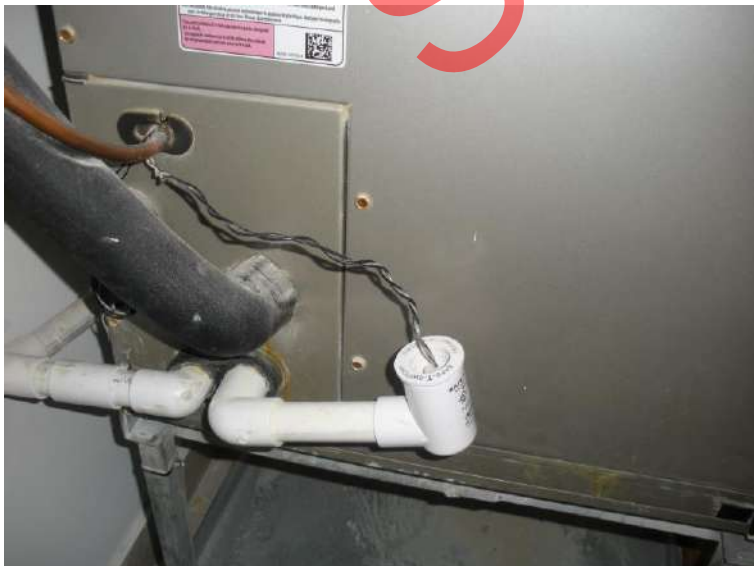
Flow switch is not on the standard position.  
Elevated flow switch position prevents the proper  
functionality of the float to shut off the unit in time  
of need.

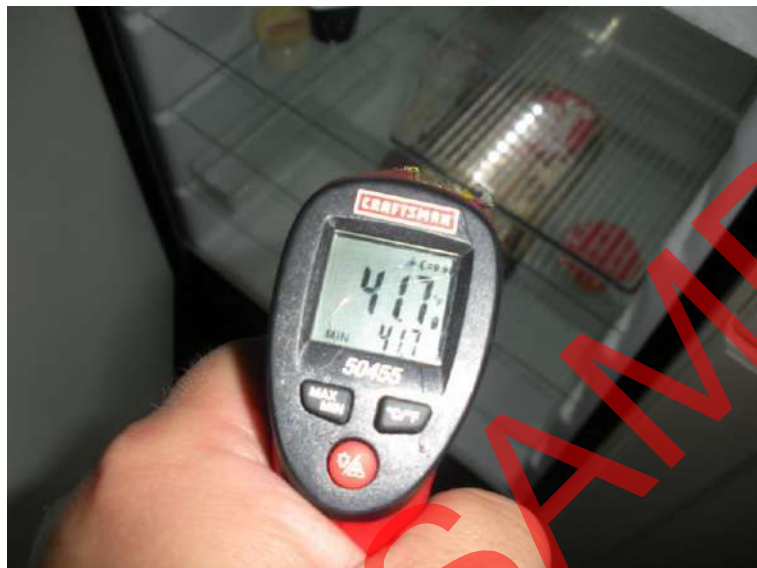
Bedroom mini fridge temperature. Temperature is a little above the standard temperature but within a cooler temperature.
