**License & Insured**  
**HI 8149 CRC 1331177**  
**MRSA3289 MRSR 3370**

**6051 NW 61st ST Parkland, FL 33067**  
**ProInspectorsFl.com**  
**954.283.8989**

**Inspected by: Joe Vandino**

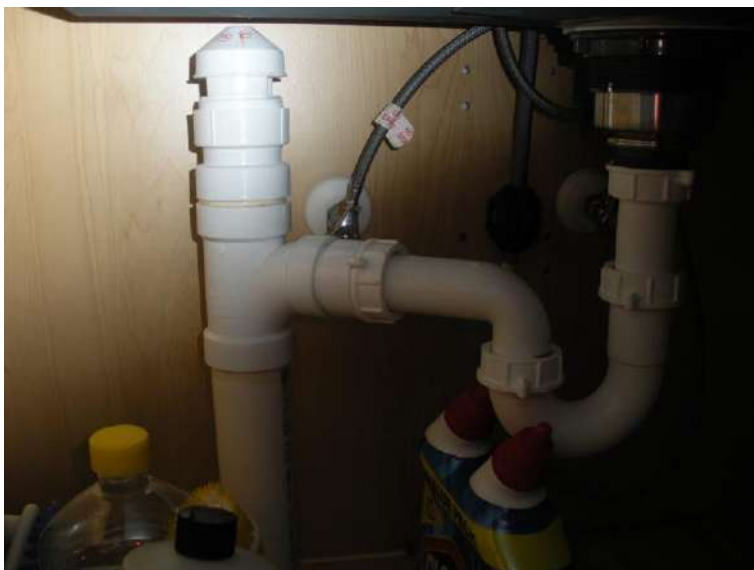
Pop Drain not operable.

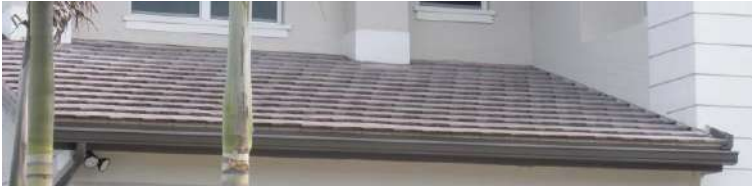
Evidence of roof leak on the goose neck connection. Roofer consultation is recommended.

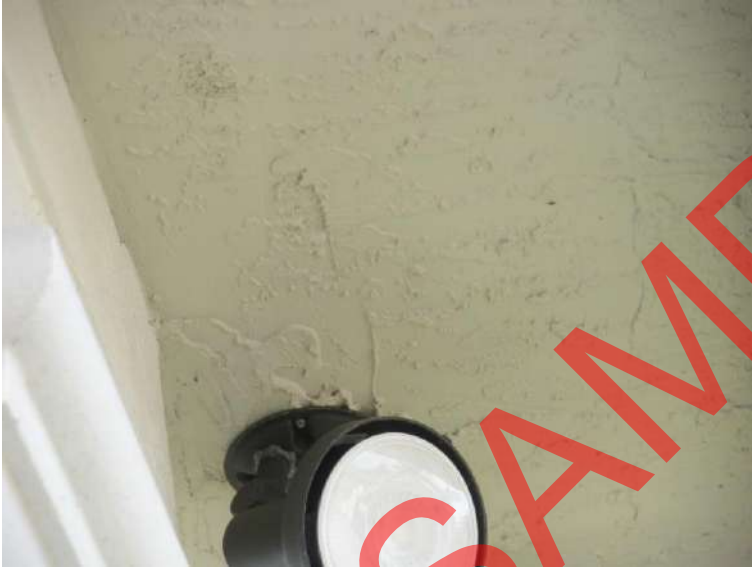
Exterior light fixtures and covers are recommended to be fully water and moisture resistant.

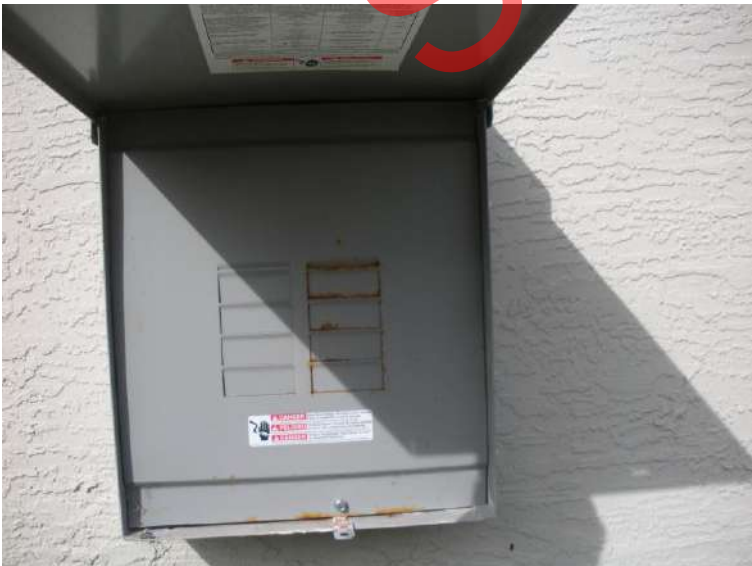
Exterior light fixtures and covers are recommended to be fully water and moisture resistant.

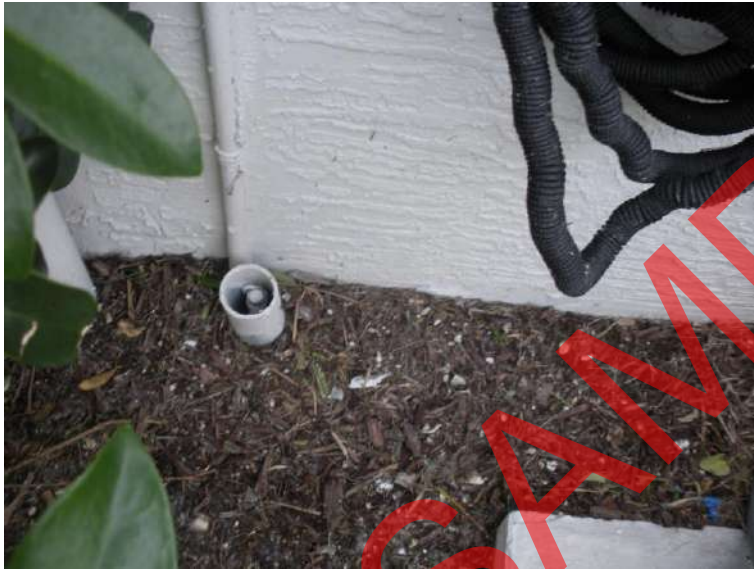
Pipe is not watertight, siliconing is recommended to prevent water intrusion.

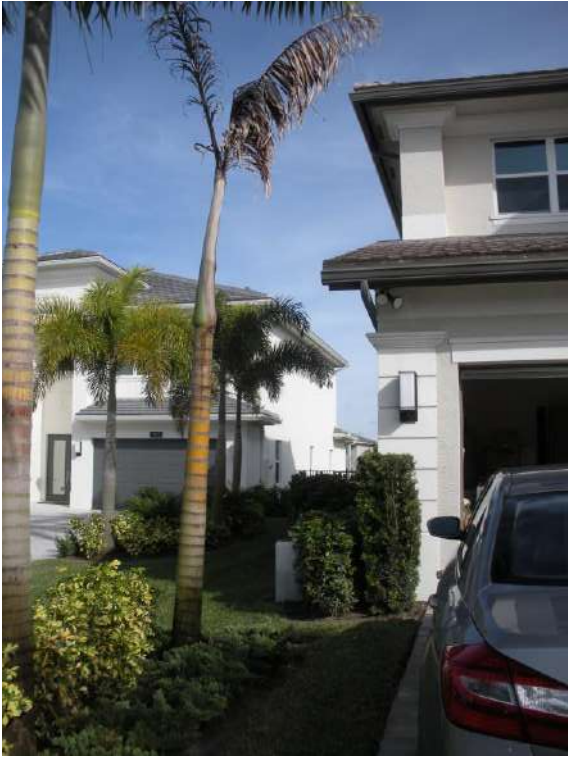
Landscape needs attention, dying palm, and some landscape is too close to the structure.

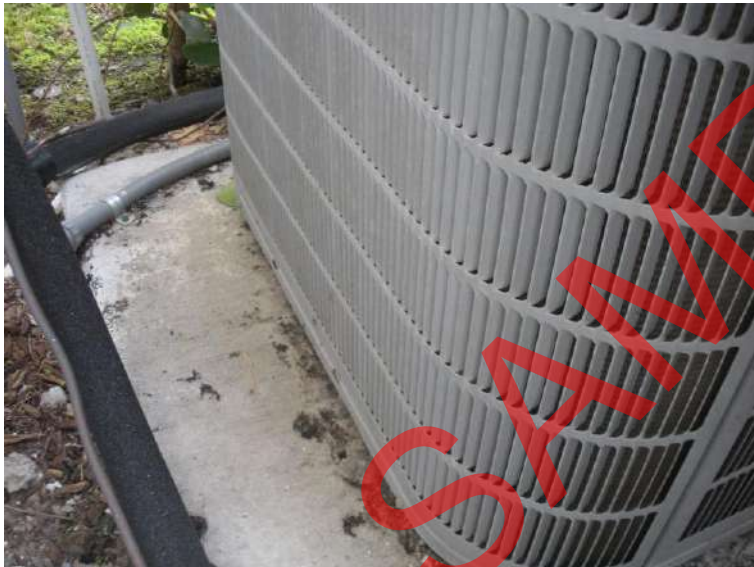
No hurricane straps are installed on the condensing unit. Each condensing unit should have 4 straps per unit as per standard.

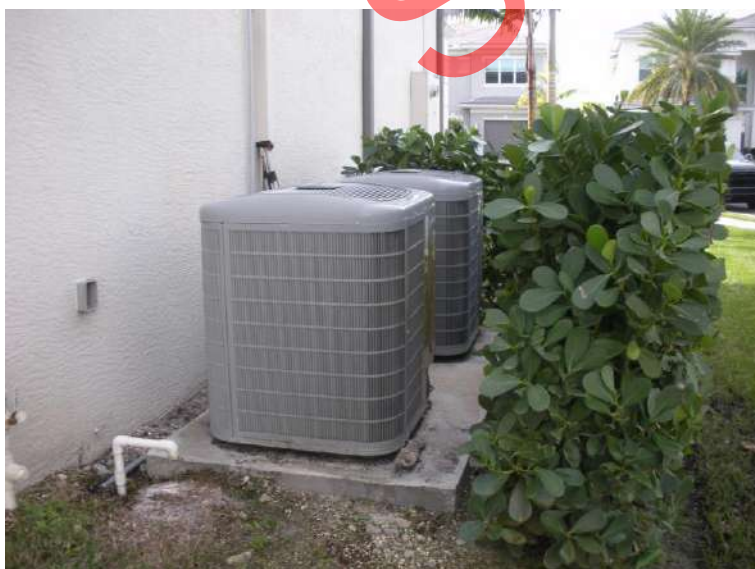
No hurricane straps are installed on the condensing units. Each condensing unit should have 4 straps per unit as per standard.

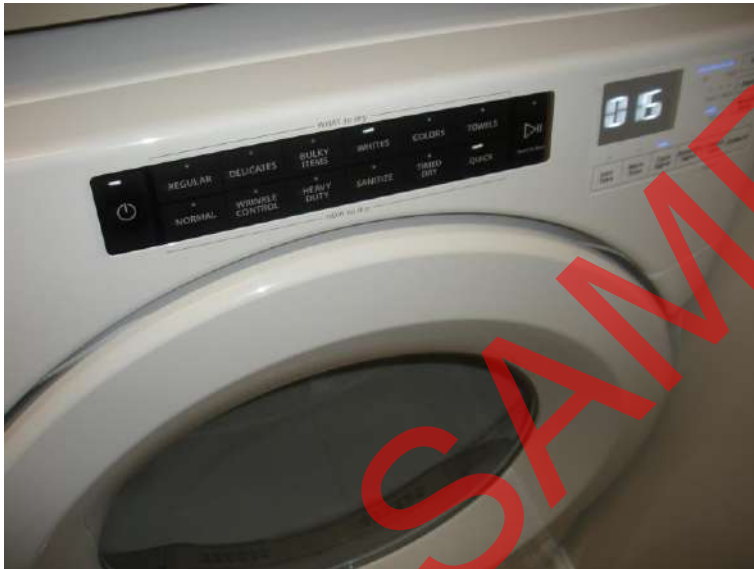
Second story washer machine was turning on but not operable. Seller agent said manufacture is supposed to service the appliance next week.

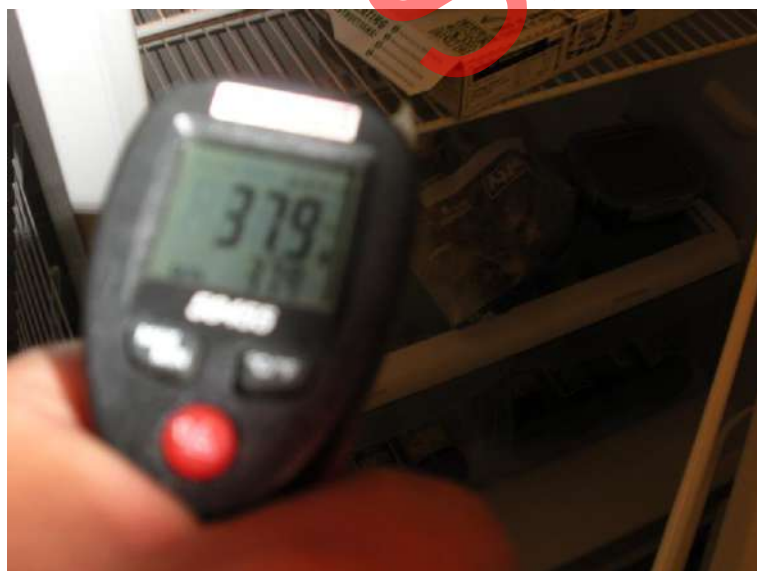
Fridge read is a little above standard temperature. Possible setting is set to a warmer setting. Appliance

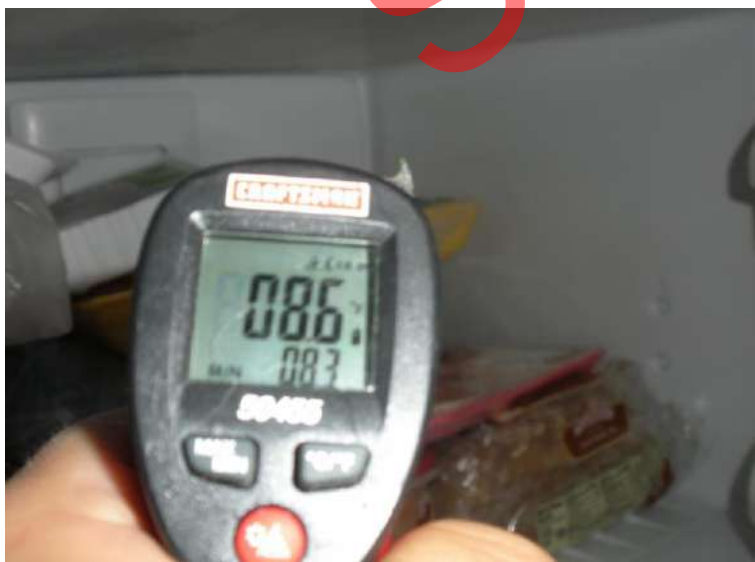
Freezer read is a little above standard temperature.  
Possible setting is set to a warmer setting.  
Appliance
